NANTICOKE RIVER BASIN

RECORDS POND DAM

PHASE I INSPECTION REPORT

NATIONAL DAM SAFETY PROGRAM

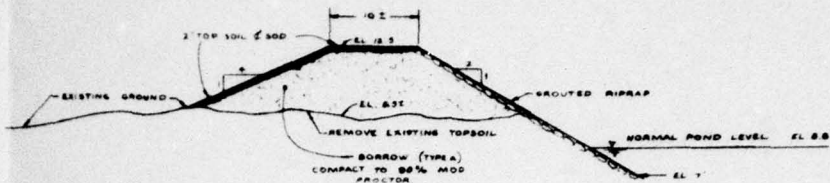
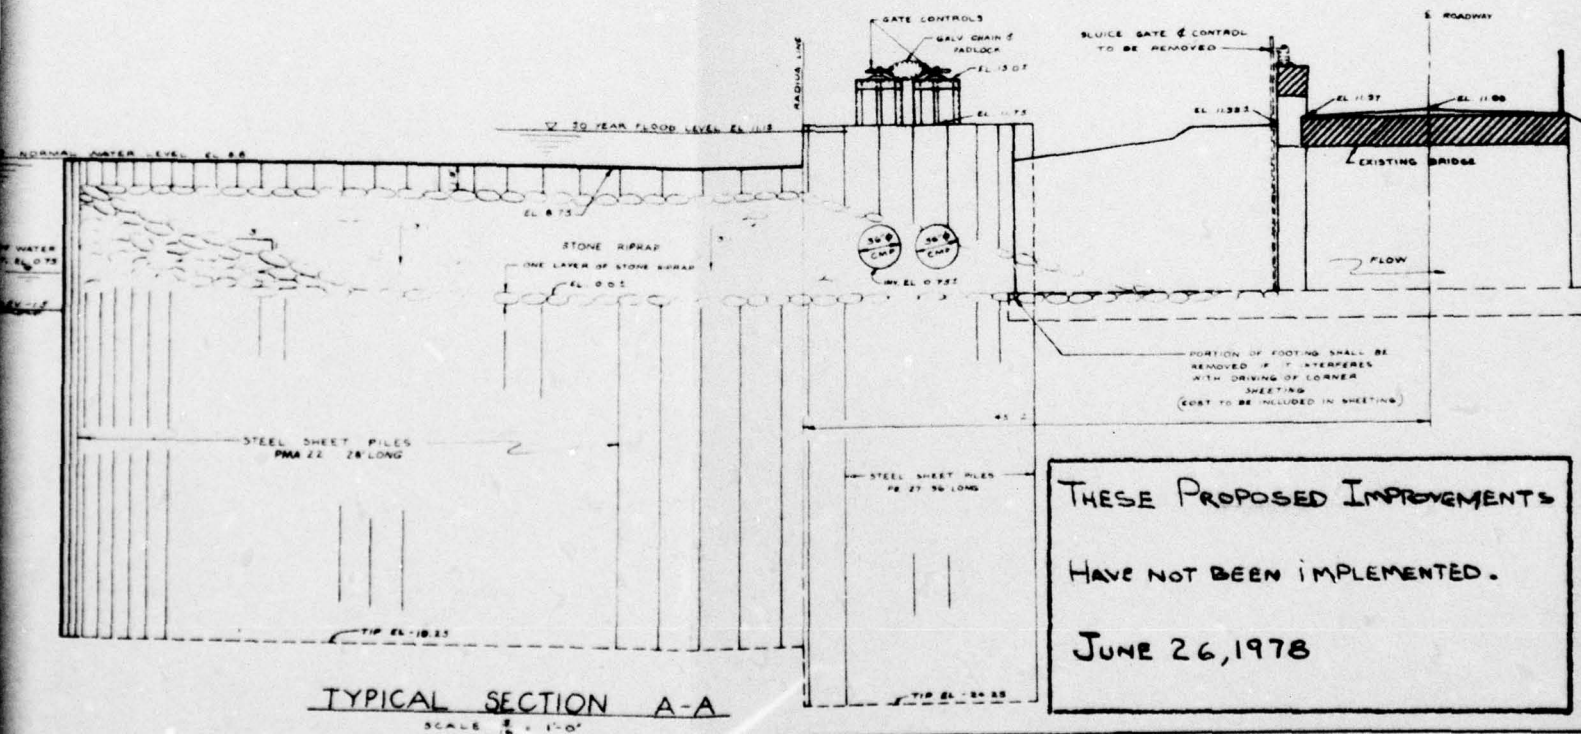
TYPICAL EMBANKMENT SECTION B-B
(ADJACENT TO COOPER STREET)
NOT TO SCALE

THESE PROPOSED IMPROVEMENTS
HAVE NOT BEEN IMPLEMENTED.
JUNE 26, 1978

Improvements/Plans were recommended by Edward H. Richardson Associates, Inc. dated 1/9/74. These included construction of a semi-circular weir just upstream of the present structure as shown in the enclosed Figure #3. The recommended spillway would be constructed of PMA-22 steel sheet piles with a downstream face and energy dissipation basin constructed of 150 pound stone riprap. Implementation of these improvements also calls for the construction of a 150 feet long earth dike located in the southwest corner of the reservoir to allow for increased storage. This dike would be lined on its upstream face with grouted riprap. These improvements/plans have not been implemented.
